## CASE STUDY

# 20" casing integrity evaluation using 80-arm multifinger caliper (MFC80)

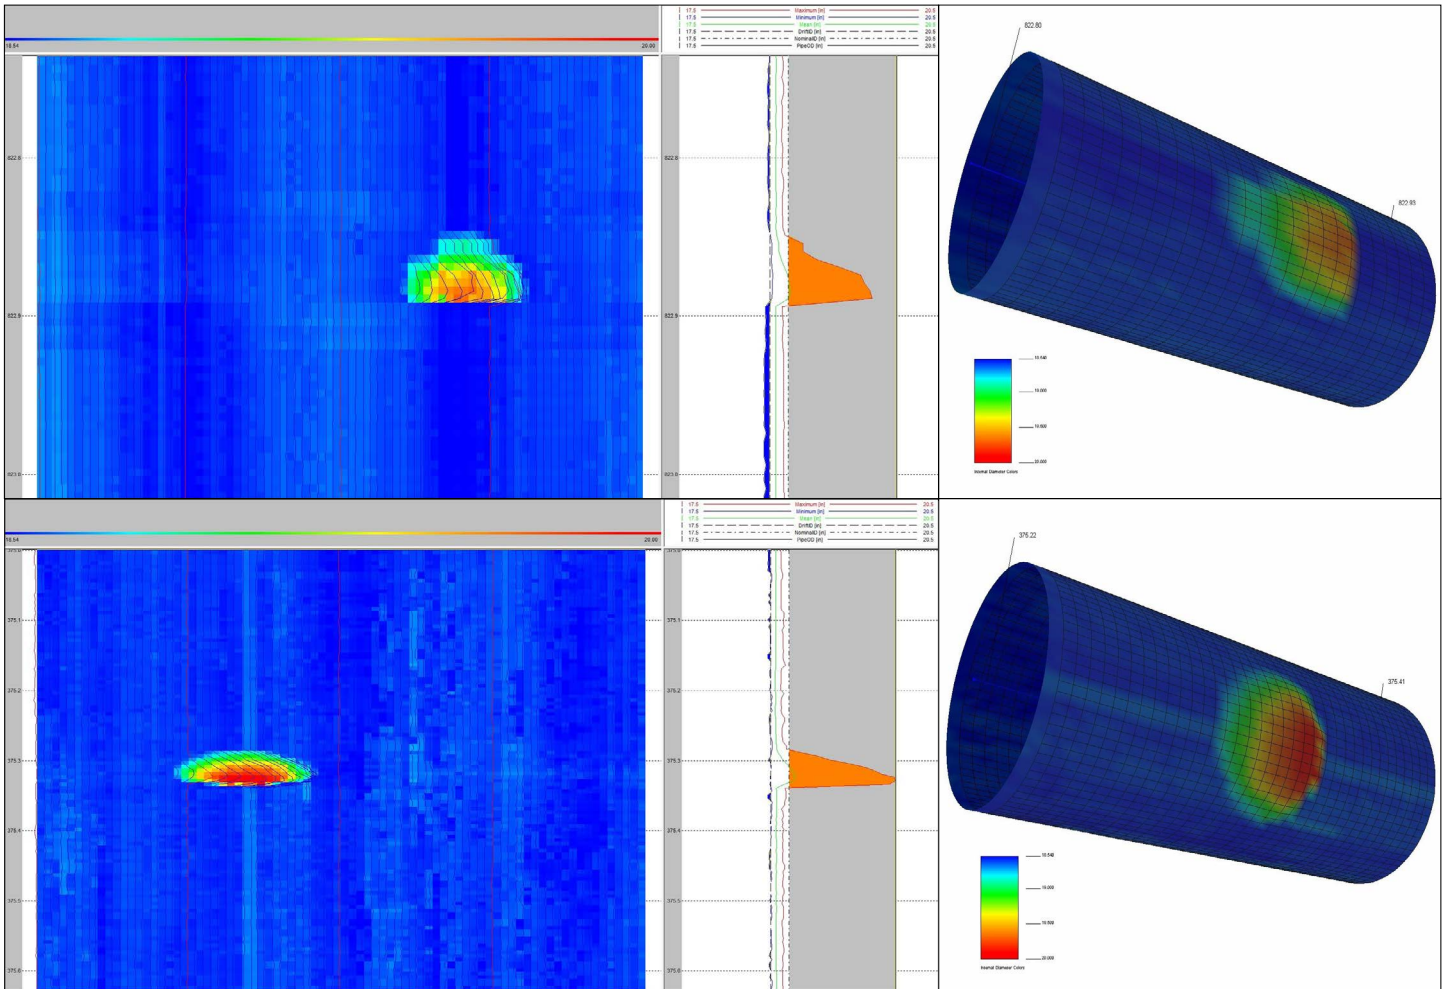
READ's data analysis report indicating damage features with 77% and 100% penetration.

The comprehensive report delivered by our ANSA team showed that the casing had multiple zones with metal loss, with several showing full wall penetration. Deposition was also found at varying degrees.

The depths of the majority of the deep penetration features matched closely with the depths where the 13 3/8" casing had been cut.
